# Manhole Inspection Summary

Manhole # S19Y\_\_030MH

**Location** Address: **2521 washington bd**

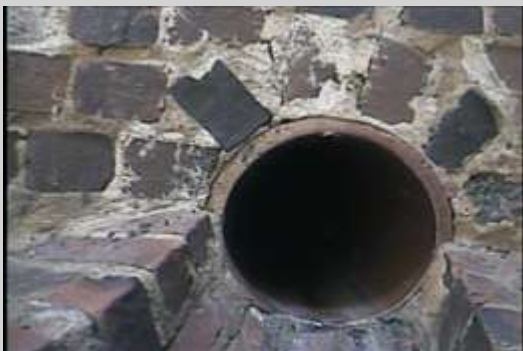
3 O'Clock Inflow

8 in. Circular Gravity Sewer  
Pipe In @ 3 O'Clock

Pipe Height: **8.4** (in.) Rod and Bar (Angled)  
Pipe Material: **Clay** ☐ Pipe Lined  
Invert Depth: **7.42** (ft.) Flow Characteristics: **Slow**  
Deposits: ☒ None ☐ Mud ☐ Sludge ☐ Debris ☐ Grease  
Silt Depth: **0** (in.) Deposits Extent:  
Infiltration: **None** Pipe Seal Cond: **Sound**

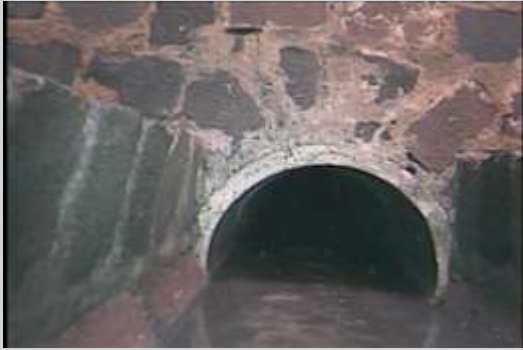
6 O'Clock Inflow

8 in. Circular Gravity Sewer  
Pipe In @ 6 O'Clock

Pipe Height: **8.4** (in.) Rod and Bar (Angled)

Pipe Material: **Clay** ☐ Pipe Lined

Infiltration: **None** Pipe Seal Cond: **Sound**
